4. TITLE (and Subtitle) WILLOW CREEK DAM SPILLWAY AND STILLING BASIN AT HEPPNER, OREGON Hydraulic Model Investigation		5. TYPE OF REPORT & PERIOD COVERED

WILLOW CREEK DAM
SPILLWAY AND STILLING BASIN
AT
HEPPNER, OREGON

Hydraulic Model Investigations

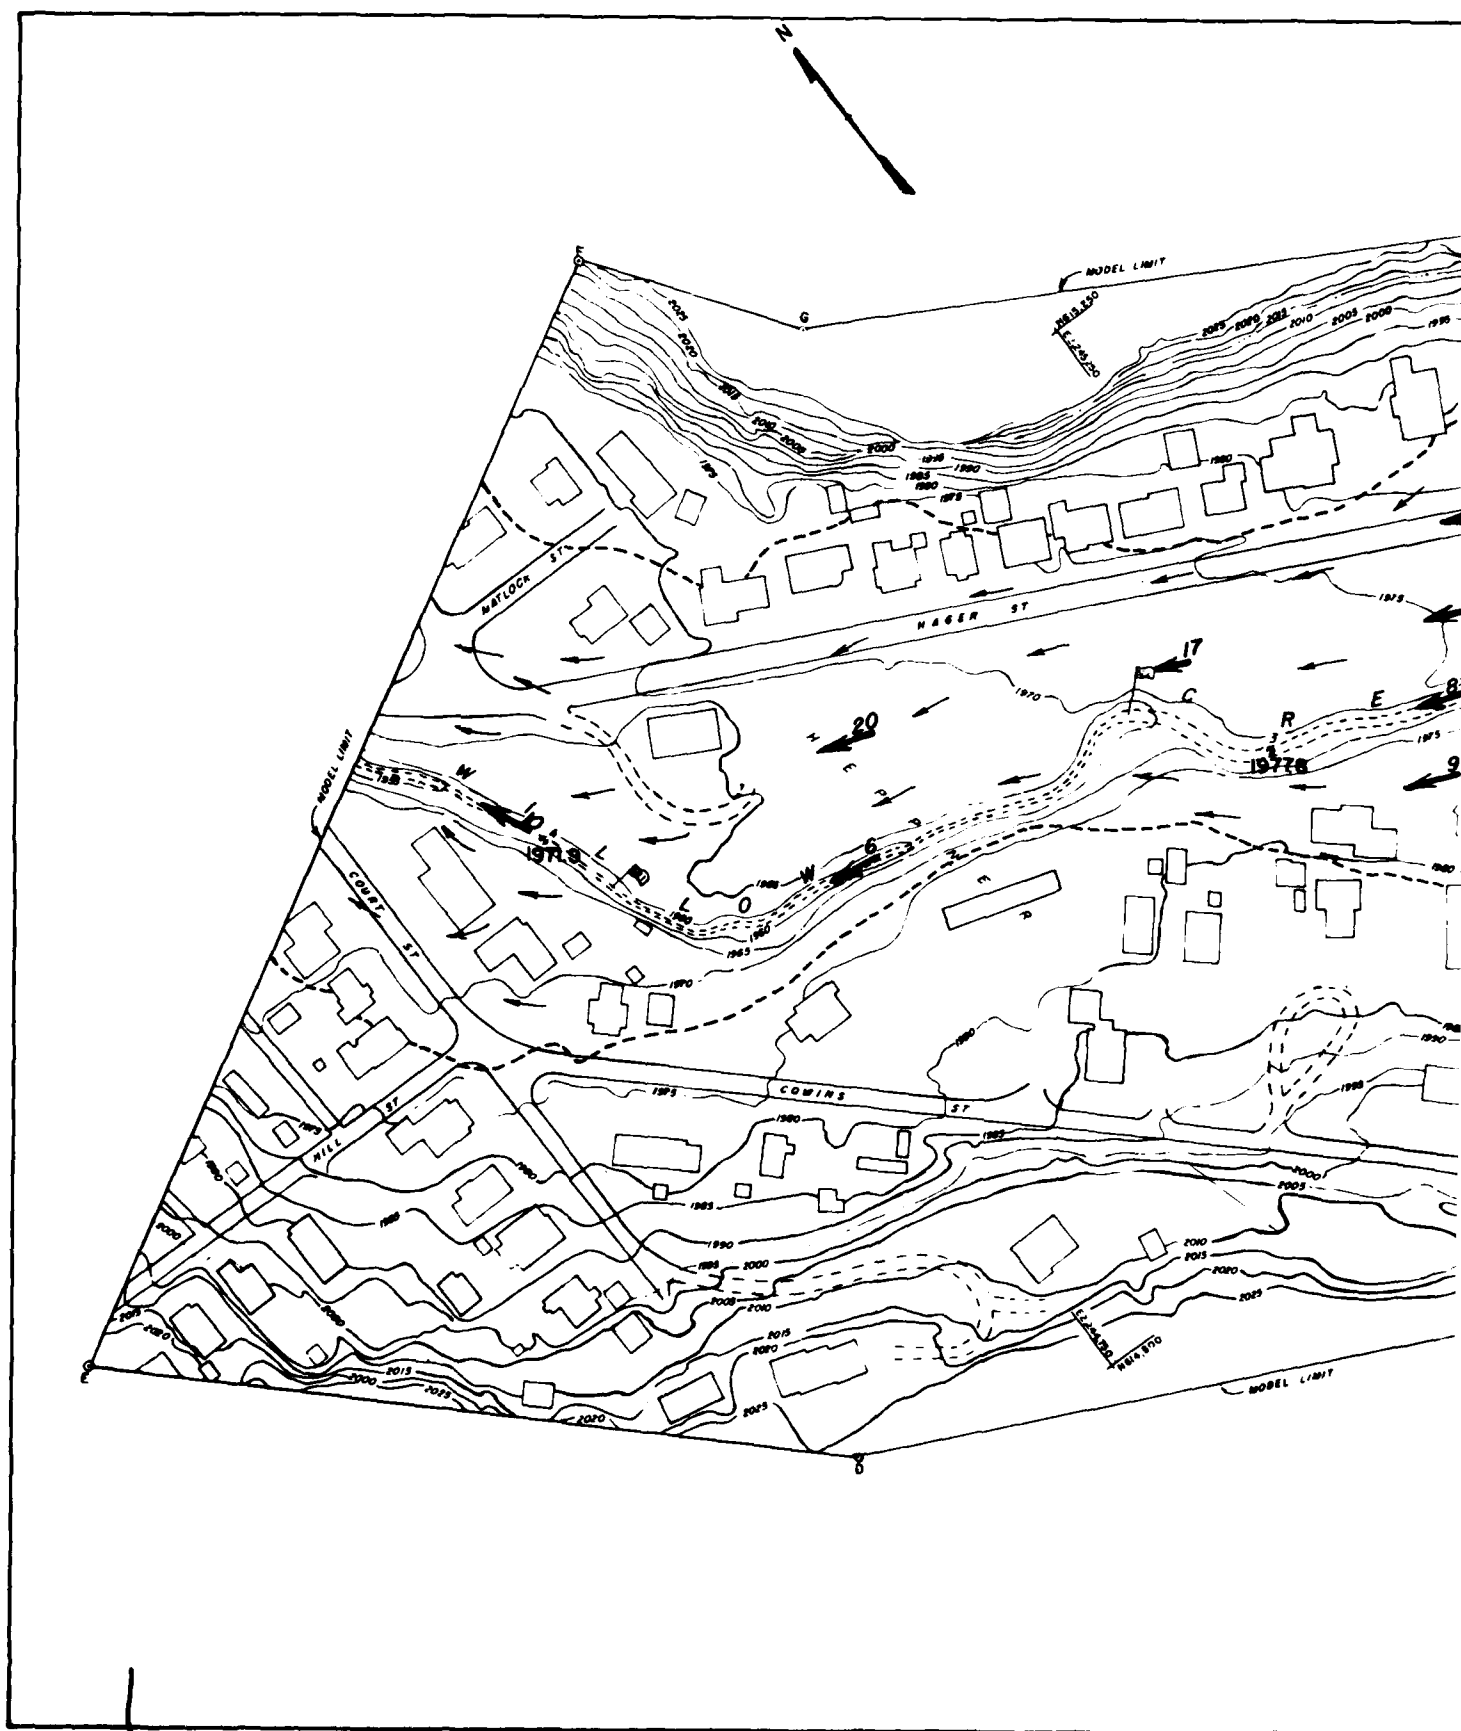
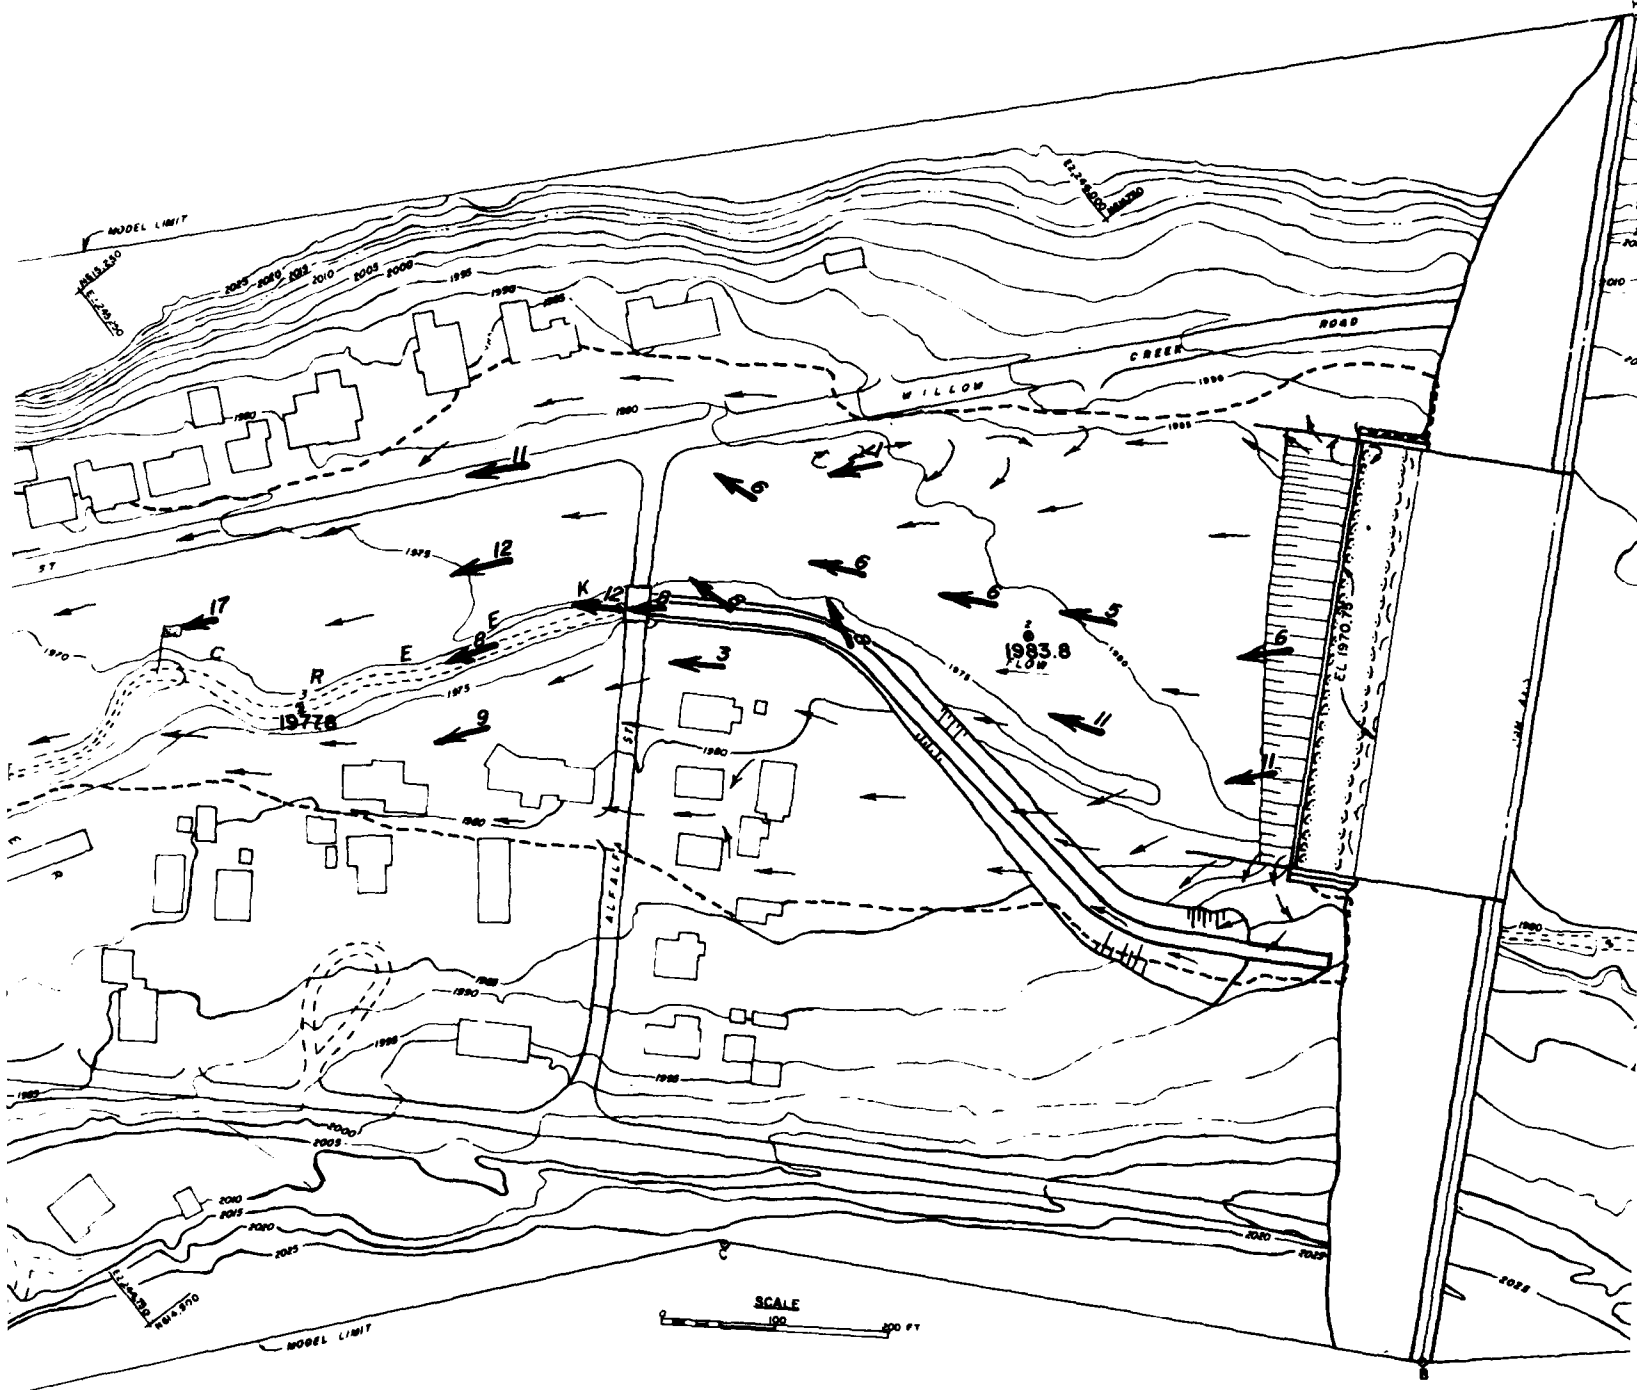
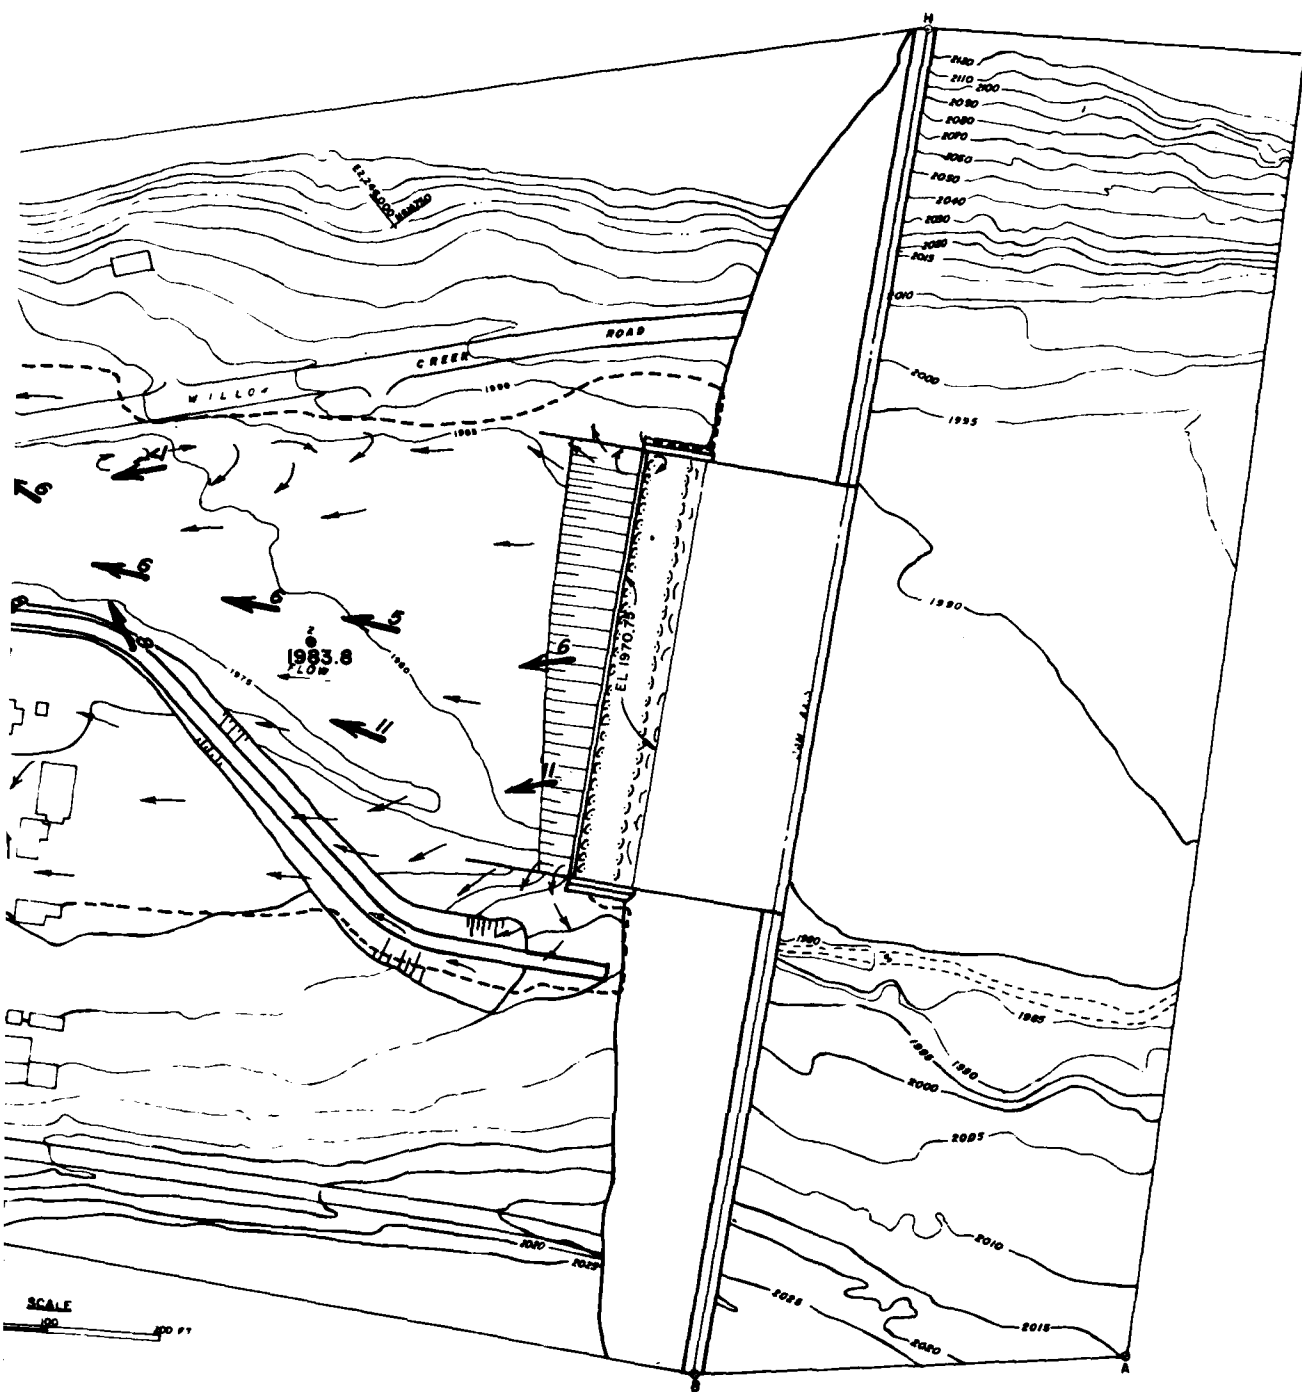
FLOW CONDITIONS
REGULATED STANDARD PROJECT FLOOD
 DISCHARGE 11 700 CFS
 STILLING BASIN FOR 18 000 CFS
 WITHOUT SCOUR

15. Performance of the Plan C basin was also evaluated assuming no scouring would occur downstream from the basin (photographs 26 and 27). Flow conditions assuming no scour of the overburden downstream with discharges of 11,700 and 18,000 cfs are shown on plates 13 and 14. Velocities across the overburden were 11 and 12 fps. Velocities were 12 and 13 fps under the Alfalfa Street bridge and 12 and 14 fps just downstream from the bridge. The velocities in the area upstream of the bridge were approximately double those occurring with the area assumed to be scoured to rock. A good hydraulic jump formed in the basin with both flood discharges (photographs 28 and 29). Maximum water surface behind the basin walls was at elevation 1989.0, 1 foot below the walls (plate 14). The jump began to sweep out of the basin with a discharge of 38,800 cfs (photograph 30 and plate 15).

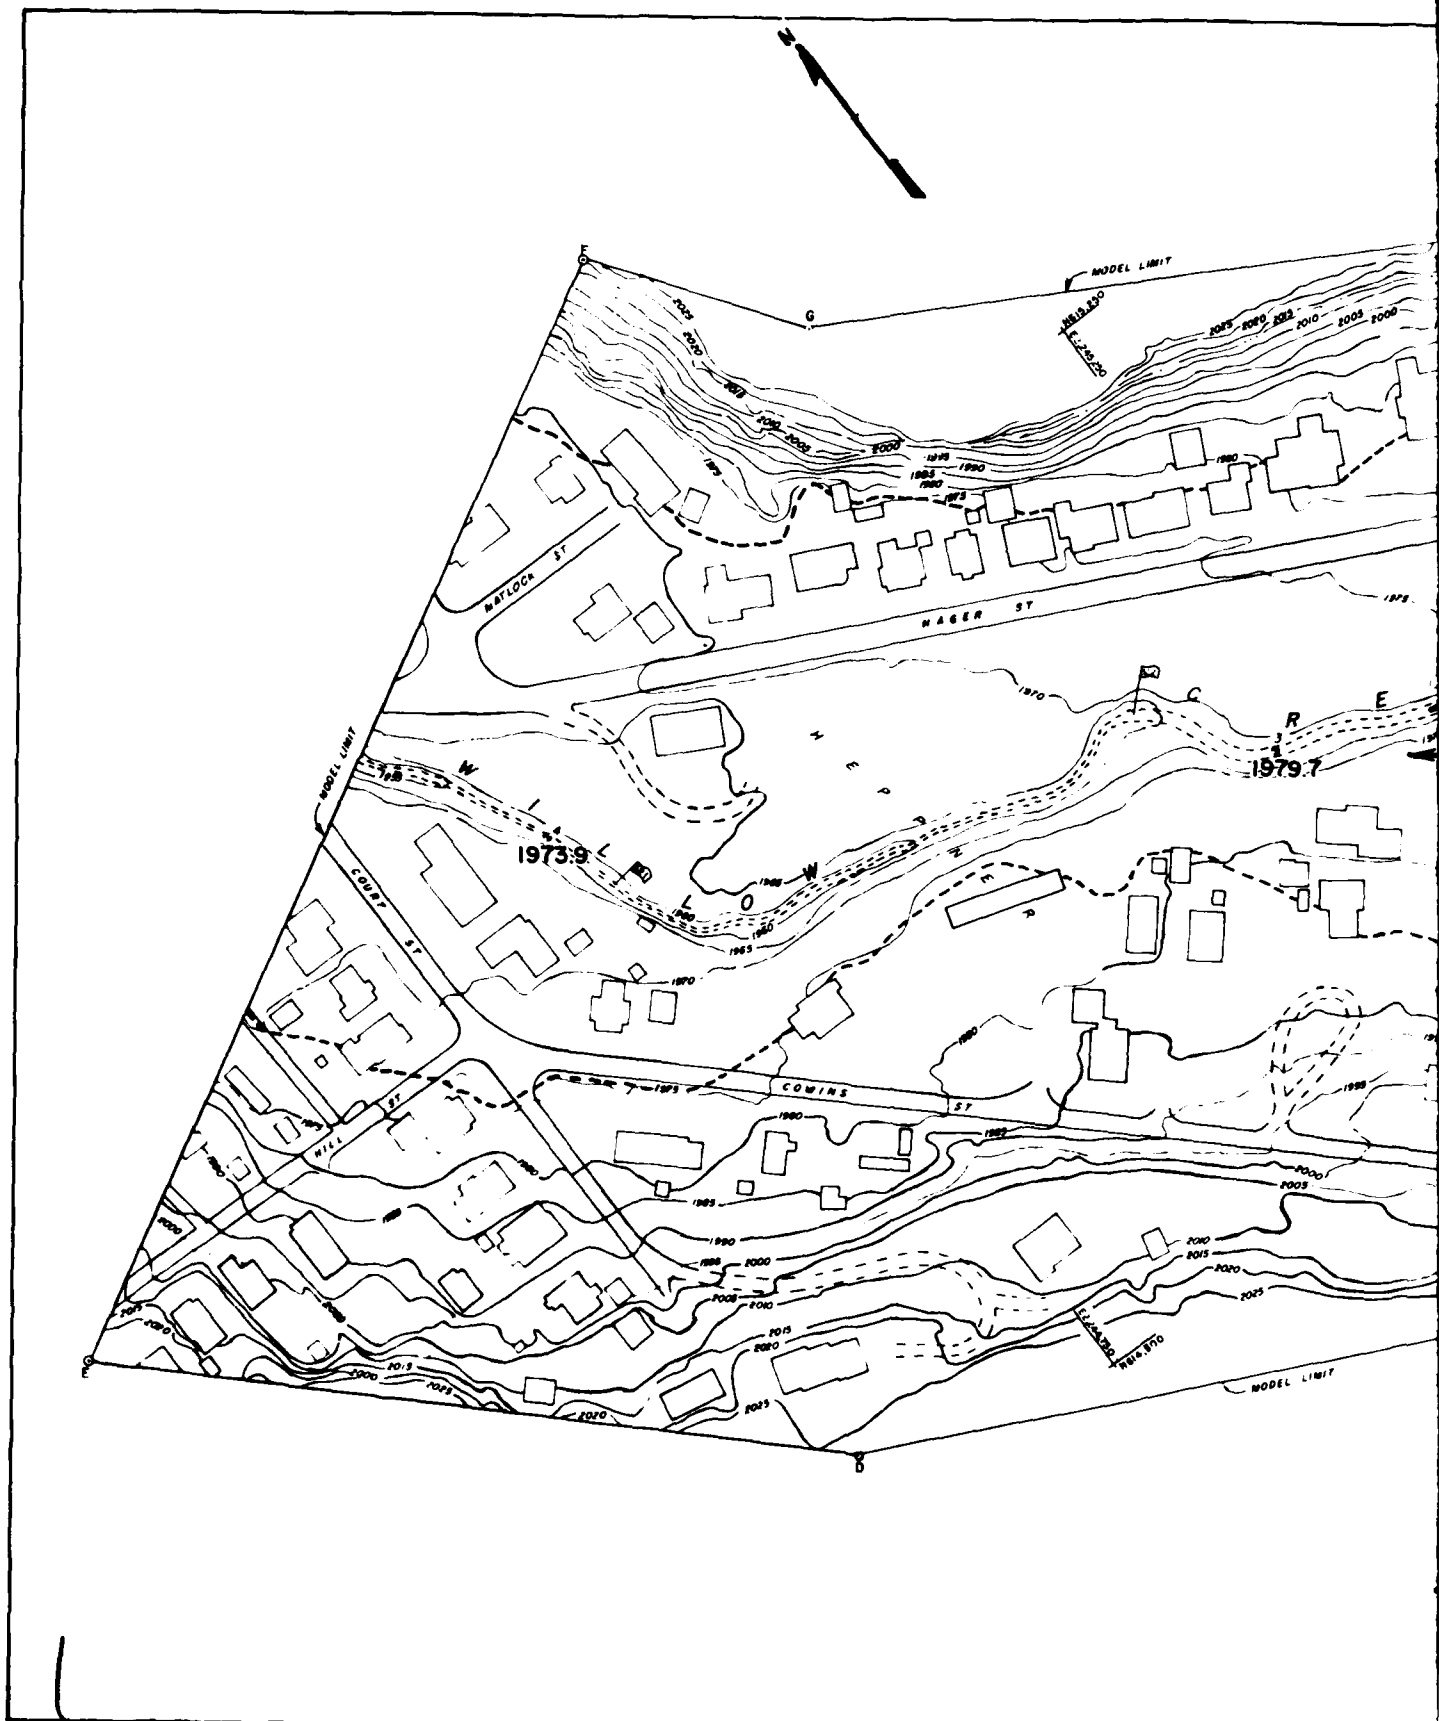
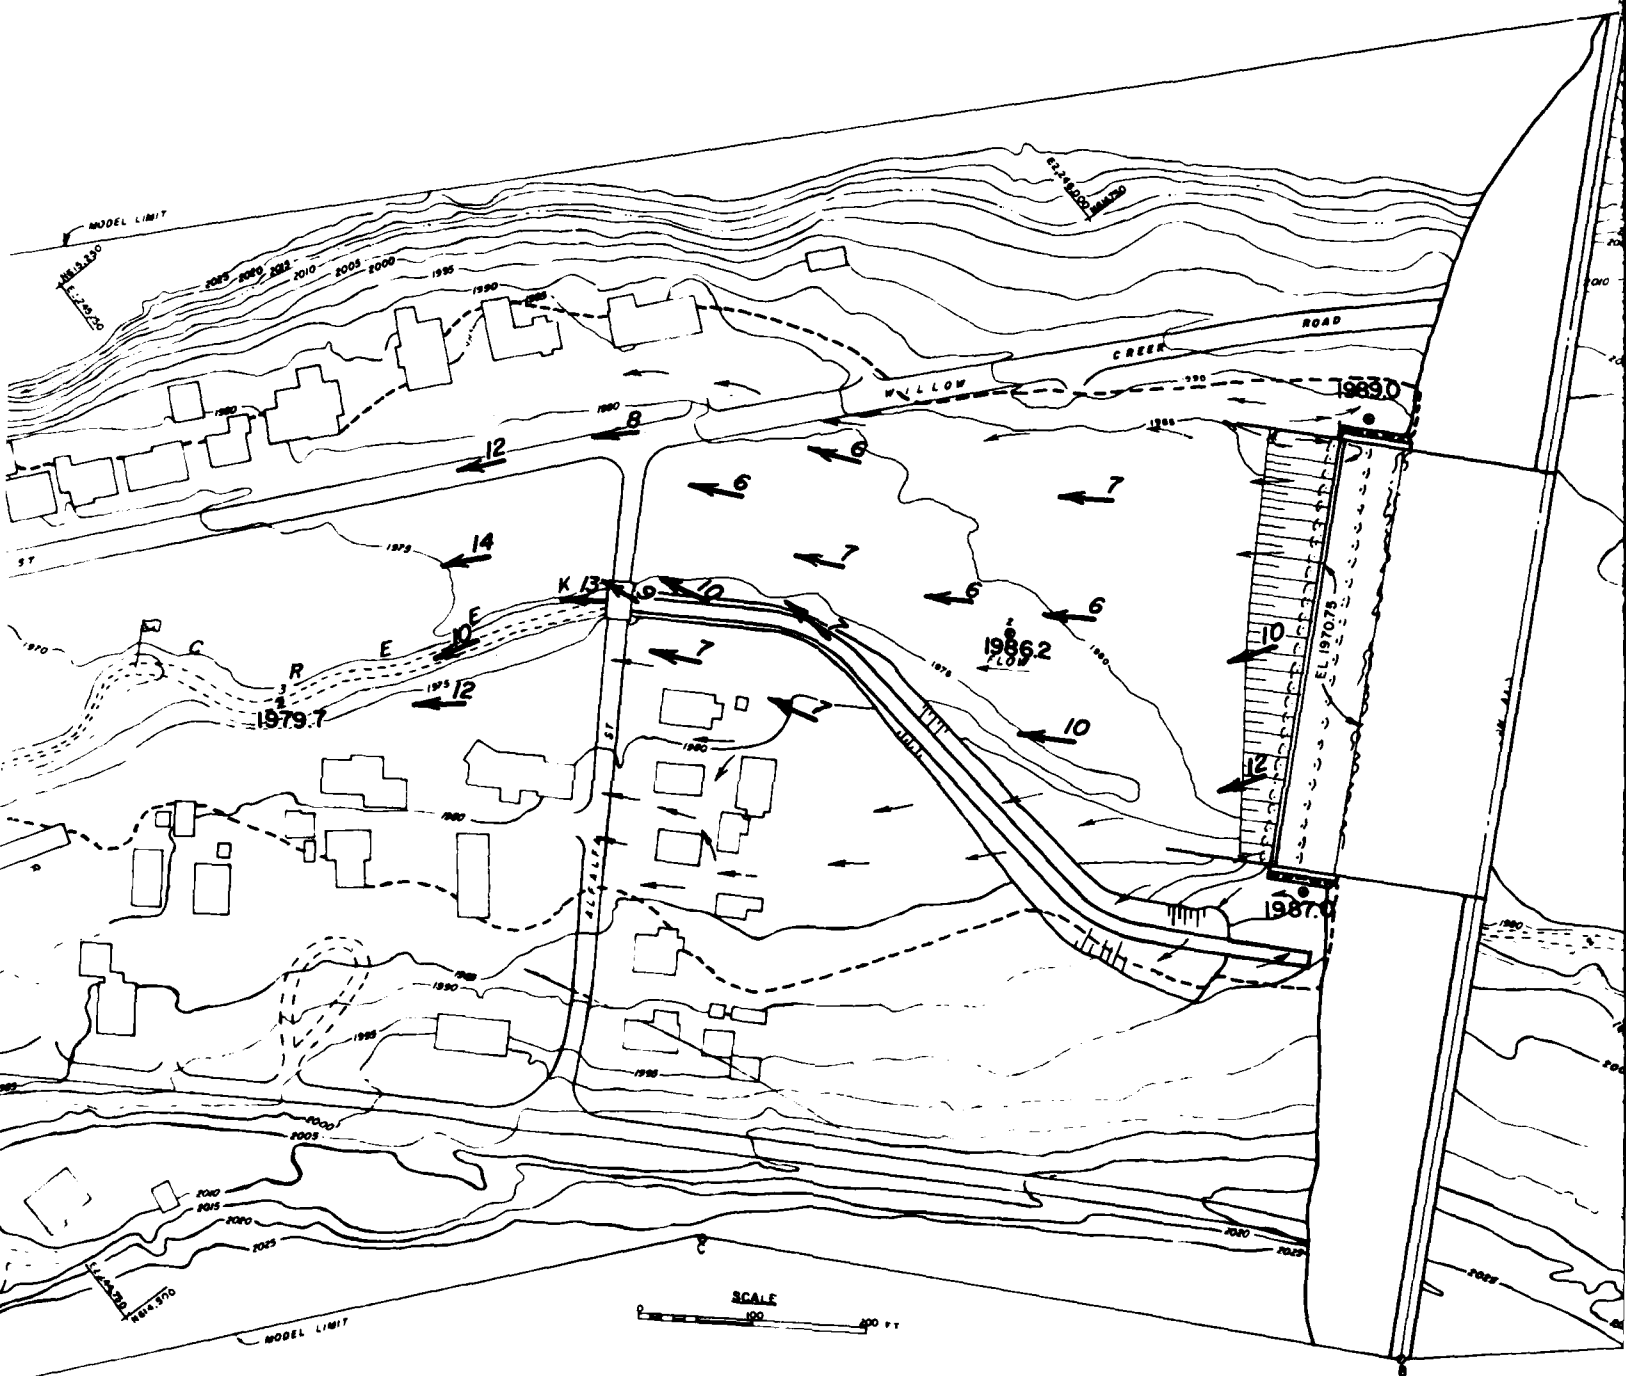
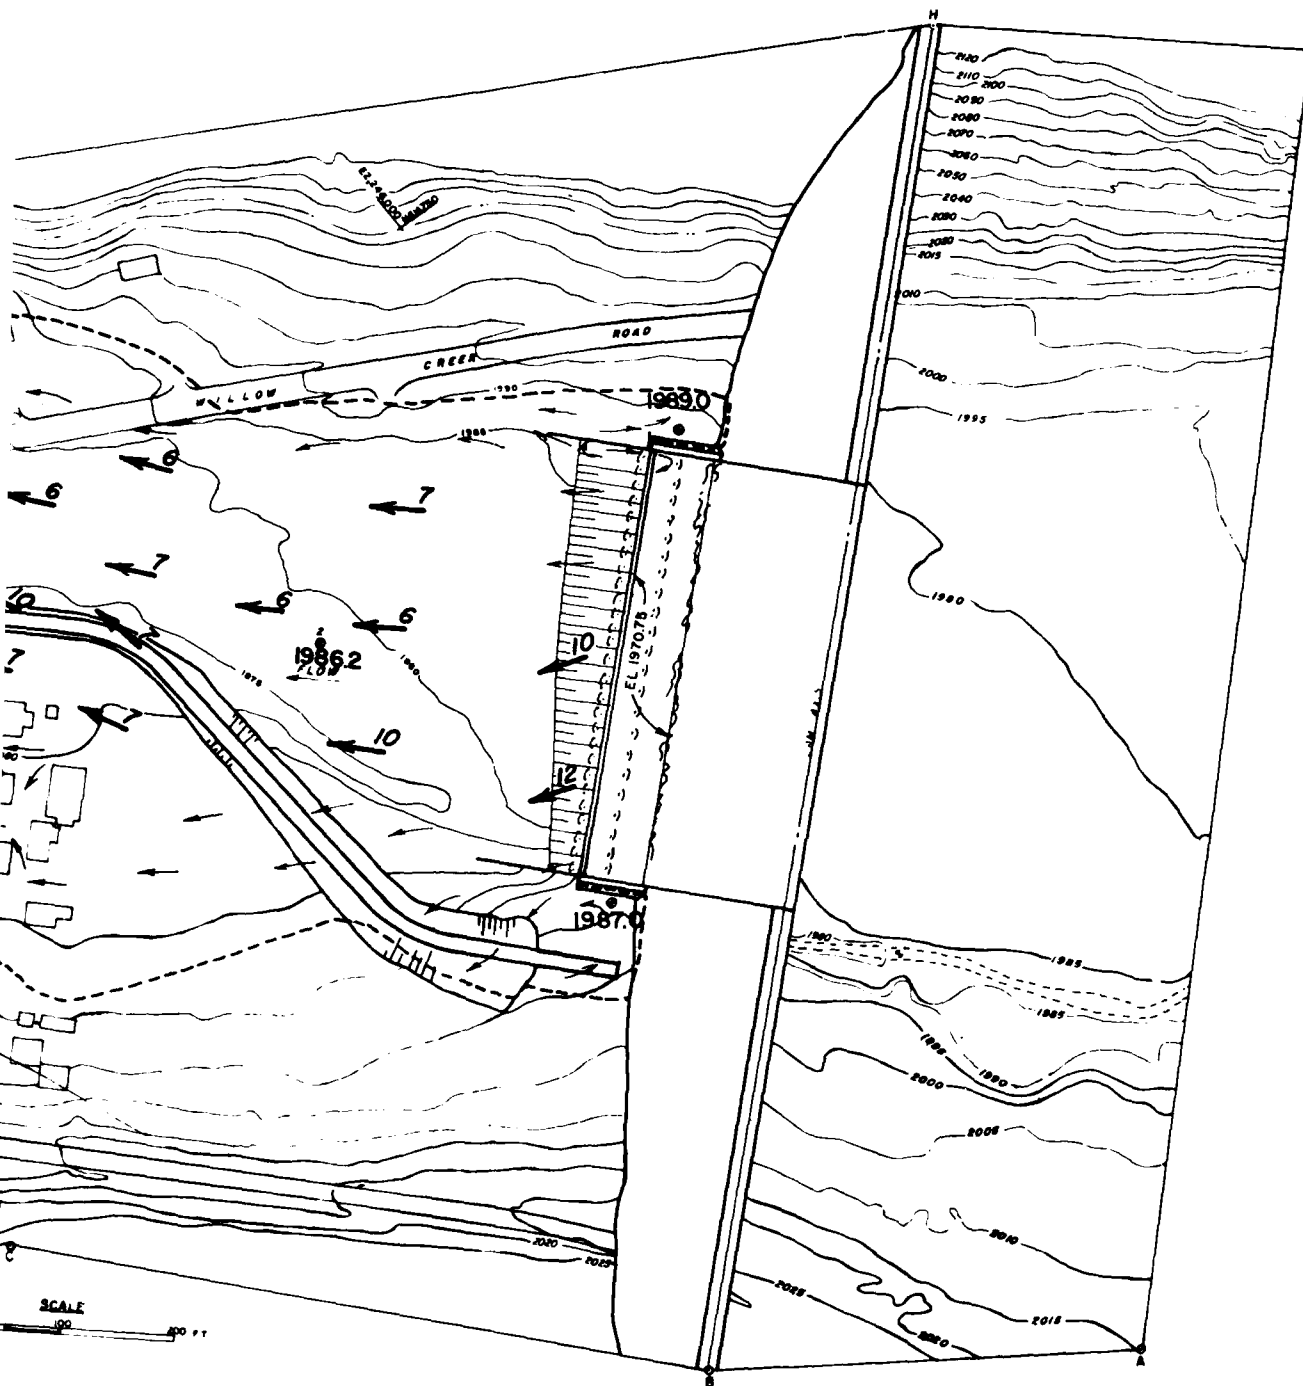
PLATE 14

FLOW CONDITIONS

STILLING BASIN FOR 18 000 CFS
WITHOUT SCOUR

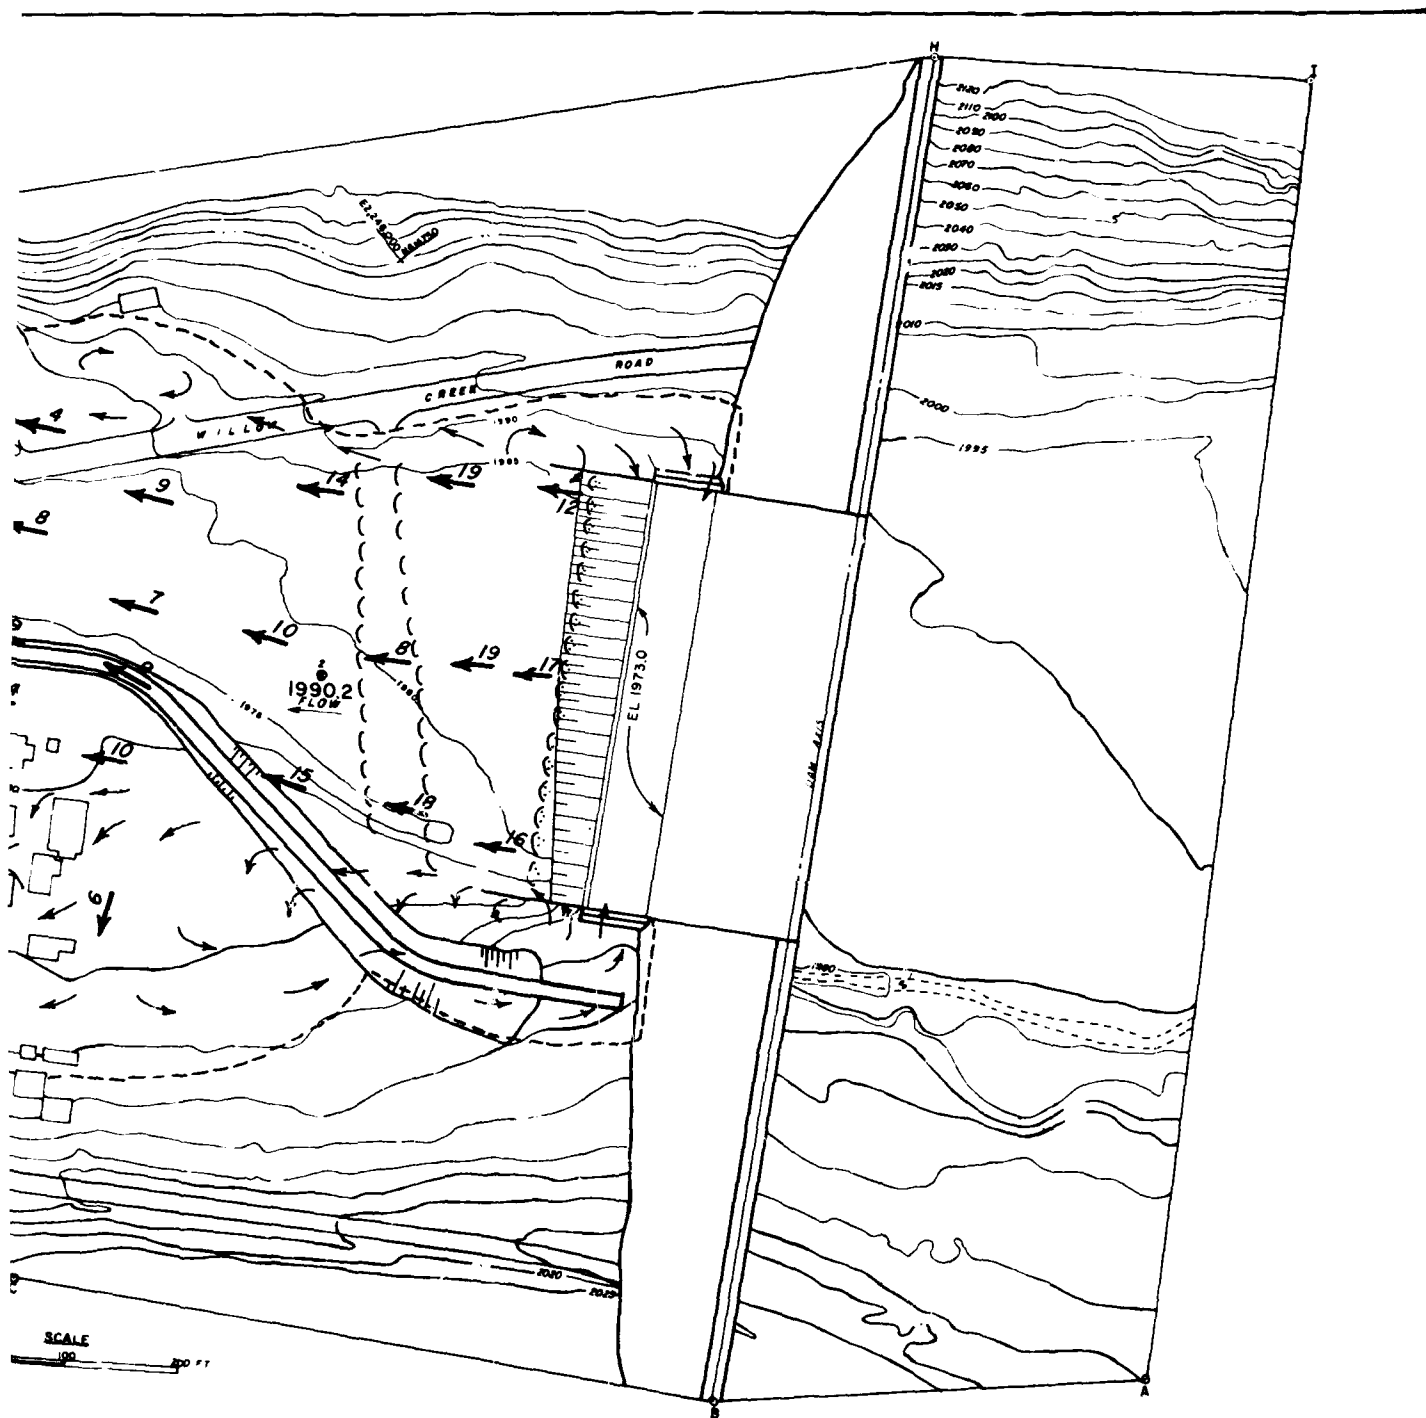
PLATE 15

FLOW CONDITIONS
BASIN SWEEPOUT
 DISCHARGE 38 800 CFS
 STILLING BASIN FOR 18000 CFS
 WITHOUT SCOUR

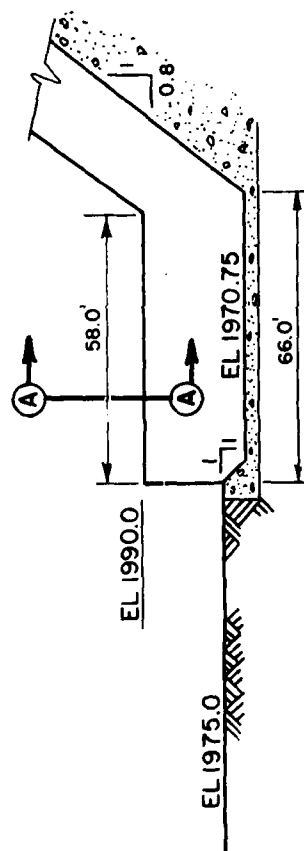
WALL SECTION A-A

STILLING BASIN PLAN C
WITHOUT CURVED BUCKET
FINAL DESIGN

16. The Plan C stilling basin without a curved bucket (plate 16) also performed well and was selected as the final design. A good hydraulic jump formed in the basin with the design discharge of 18,000 cfs (photograph 31). Impact pressures on the basin floor 26 inches from the intersection with the spillway chute were 77 feet of water with a discharge of 91,700 cfs, 59 feet with 65,000 cfs, and 43 feet with 45,000 cfs.

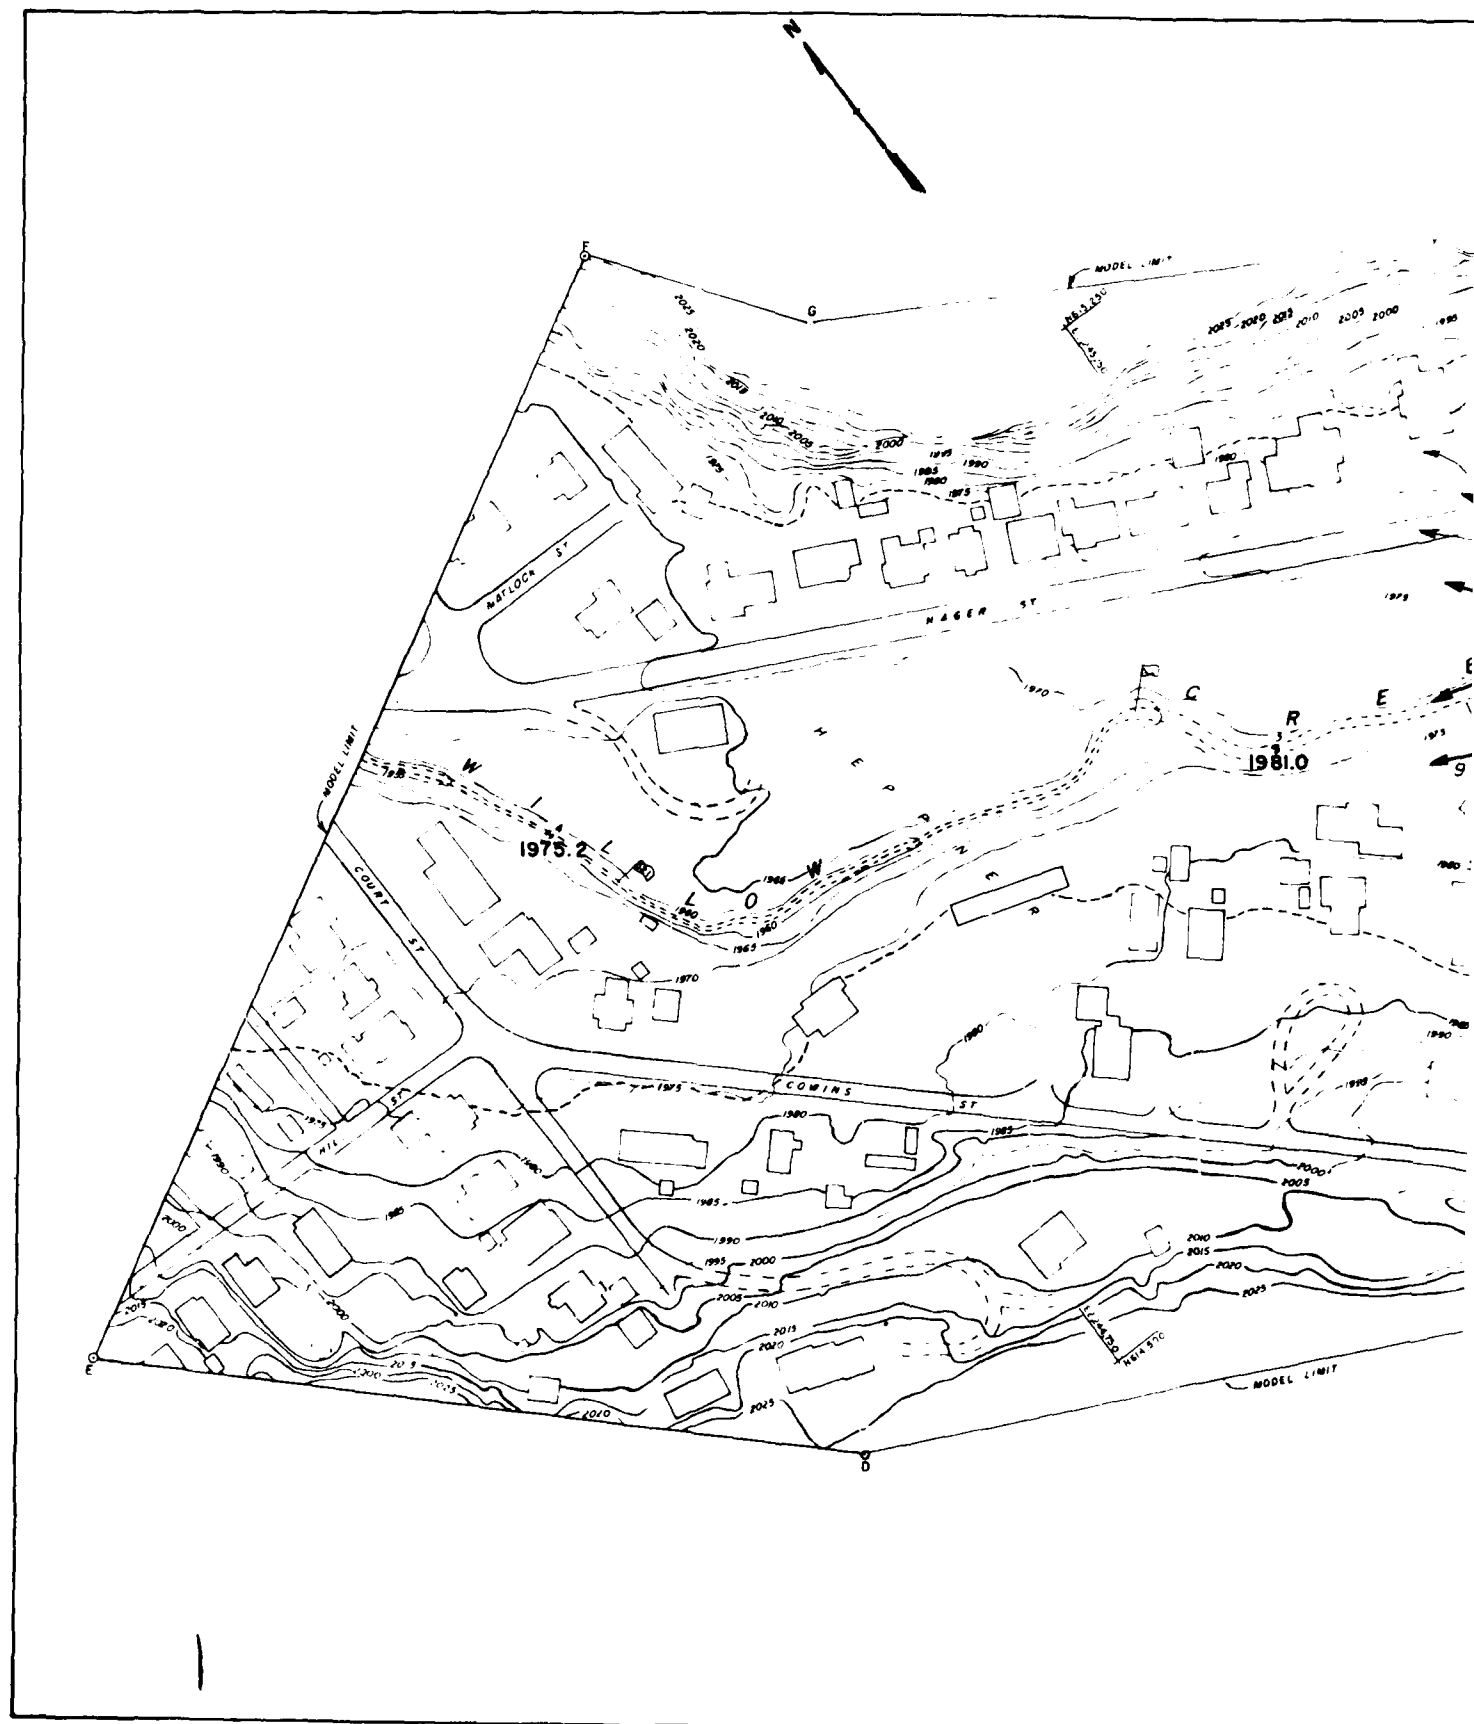
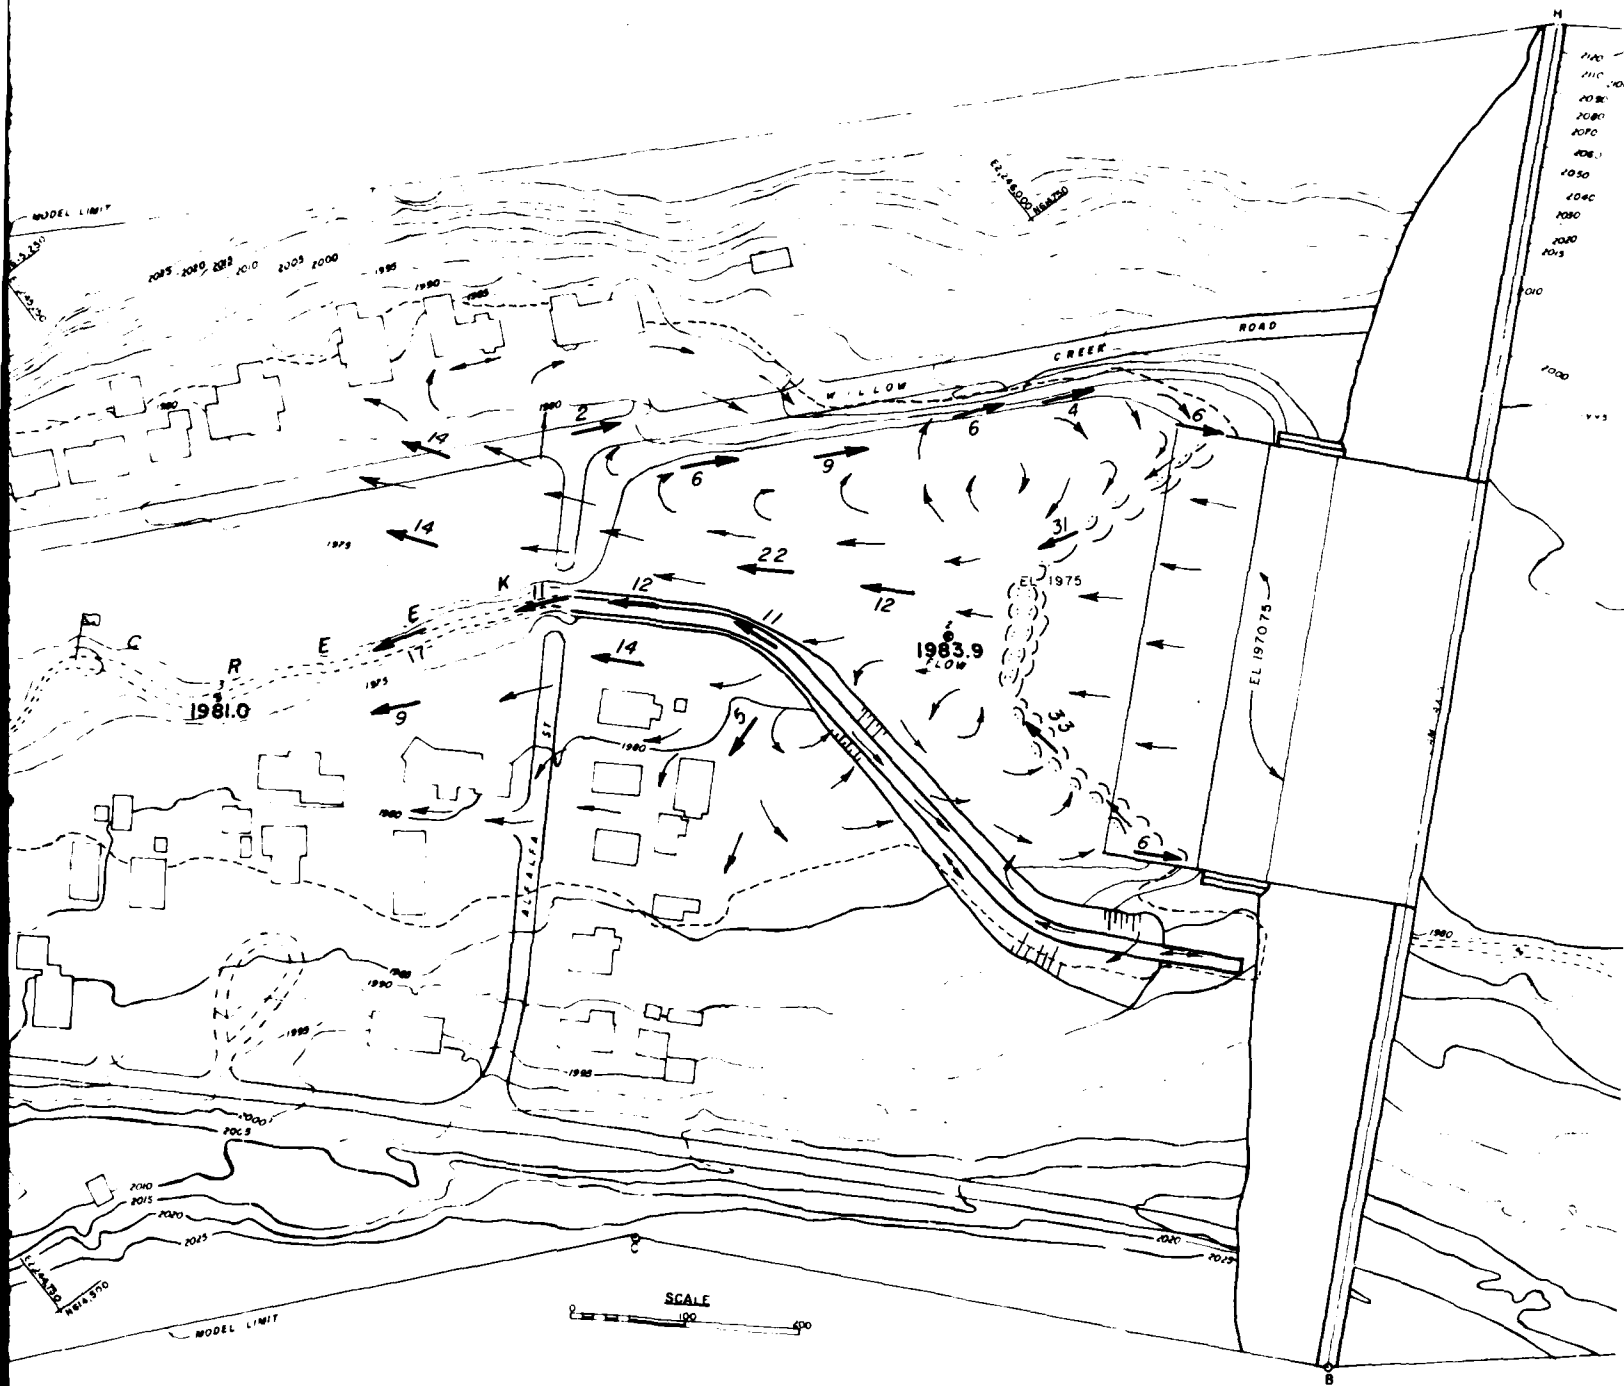
FLOW CONDITIONS

DISCHARGE 24 000 CFS

STILLING BASIN FOR 18000 CFS WITH SCOUR
AND NO END SILL

17. Flow conditions assuming the end sill washed out and the area immediately downstream scoured to rock are shown on plates 17 through 19 for the greater-than-design-discharges of 24,000, 45,000, and 91,700 cfs. Flow swept out of the basin and a hydraulic jump formed in the scoured area downstream (photographs 32 and 33). With 91,700 cfs, the jump was at Alfalfa Street (photograph 34). Velocities at the jump were as high as 46 fps.
